Iron & Steel Technology[®]

- Cold Sheet Rolling, Processing, Coating & Finishing
- AIST 2017 North American Galvanizing Lines Roundup

Surface Chemistry–Based Defects on Steel Sheet, Investigated by SEM/EDS

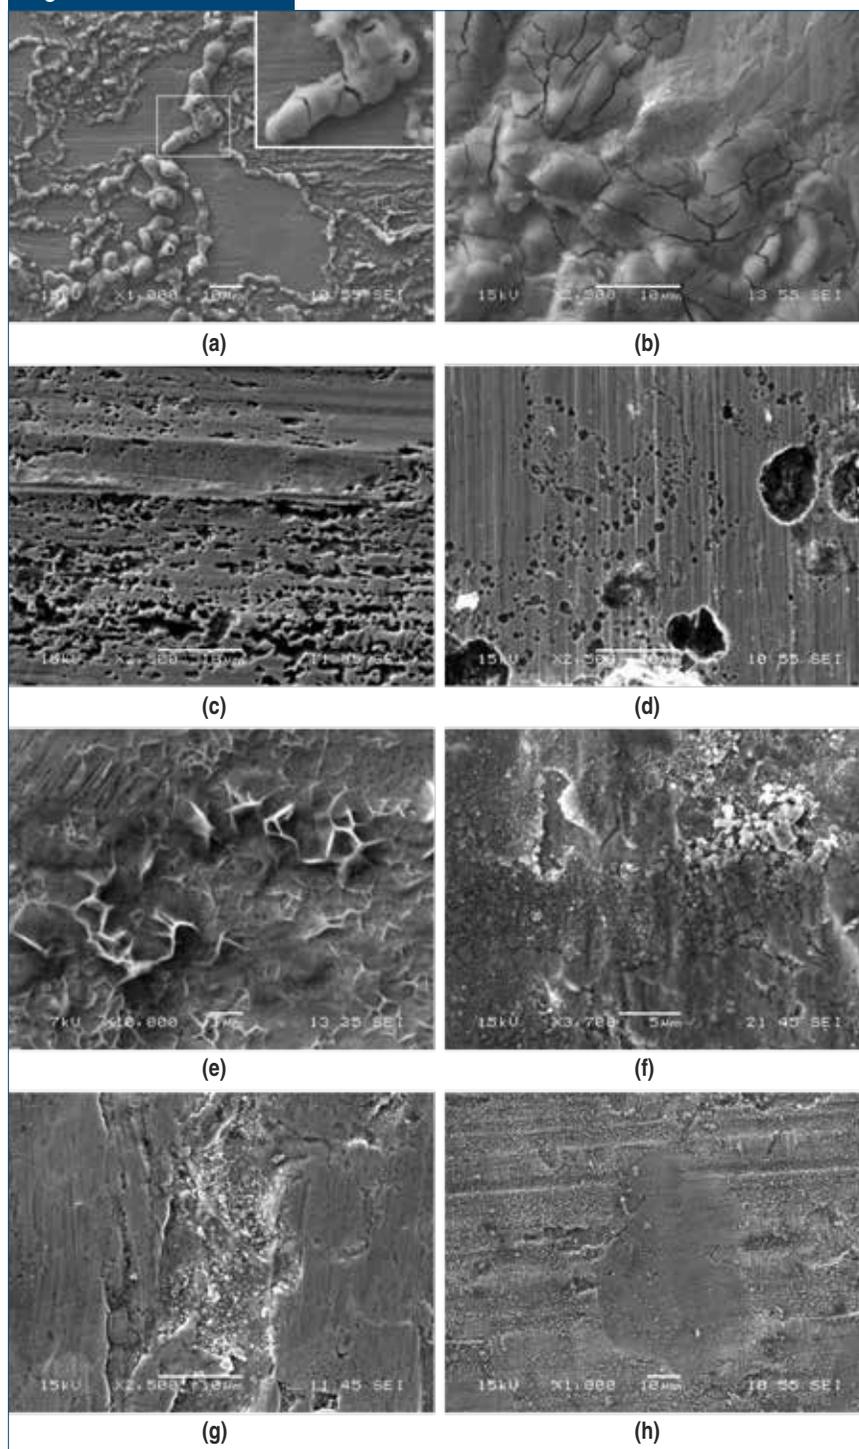
Figure 1

Chemistry-related defects that can occur on steel sheet do not cover only a wide range of visual appearances; their microscopic appearance, as observed for instance with a scanning electron microscope (SEM), can also vary significantly. Particularly where corrosion products are involved, there are some frequently occurring features. Corrosion products quite often have the appearance as shown in Fig. 1a: smooth, globular structures that have a clear pattern that suggests a meandering growth over the surface, now and then interrupted by small holes and cracks (see inset). These structures consist of oxides. A possible explanation of the small holes is that under aqueous conditions, the oxides were deposited as a hydrated gel,² which was subsequently locally ruptured due to the evaporation of the water. These structures are often characteristic for atmospheric corrosion. It is also often found that the oxides have developed a cracked morphology, as shown in Fig. 1b, likely also formed during drying.

Locally, quite severe corrosive conditions can occur, which are often accompanied by widespread etching. These are tiny holes of submicron dimensions that usually start off individually, but can grow to larger sizes and join to create significant cavities in the surface (Figs. 1c and 1d). The pattern of the etching holes in Fig. 1d suggests that the etching holes have likely developed along grain boundaries. Etching holes are the result of a corrosion process in which the corrosion products were soluble, e.g., in a locally acidic environment. This leaves behind the etching holes where the metal has disappeared, while the corrosion products may have been deposited elsewhere. Local acidic conditions can occur in cases where anodic and cathodic regions are separated, e.g., in case of crevices.³

At high magnifications, sponge-like porous structures are sometimes seen, as shown in Fig. 1e. The exact nature and mechanism of formation of these structures is not known, but organic material is sometimes involved, as well as oxides. It is possible that some of these structures form in between windings in a coil, which are ruptured when opening the coil. The porous nature of the material that had grown between the windings is then revealed.

Sometimes, the oxides have a very irregular, broken-up appearance. This is illustrated in Fig. 1g. This appearance is mostly evidence of damage to the oxide structures due to a downstream process step.

Fig. 1h shows an example of submicron particles on a cold-rolled surface that were flattened into the general surface by the wet tempering process. This kind of evidence can be used to conclude that these features did not result from the wet temper process, but were created upstream.

Examples of the morphology of some chemistry-related defects on steel.

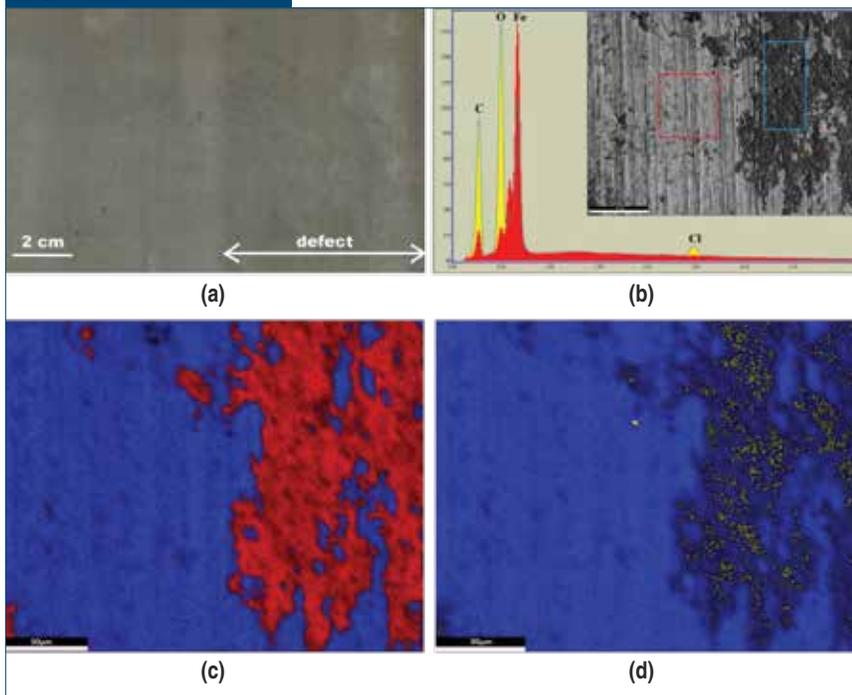
Figure 4

Cold Rolling — Corrosion — Most surface chemistry defects that occur on full hard steel concern corrosion caused by coiled-in rolling emulsion left behind on the surface due to an insufficient blowoff or sub-optimally functioning wipers. Subsequent storage of the coils may then result in corrosion in the shape of oxide spots or bands of more or less severe staining. In some cases, the corrosion process was triggered by traces of chlorine originating from the pickling process (acid carryover) or by salts originating from the water used to prepare the rolling emulsion. An example of full hard strip corrosion due to acid carryover is presented in Fig. 4. Here, a 6- to 7-cm-wide

Visual appearance of a grayish-brown band of staining on full-hard steel (a), energy-dispersive x-ray spectroscopy (EDS) spectra of a staining spot (blue outline) and of adjacent non-stained surface (in red) (b). The inserted image shows a backscatter image comprising both surfaces. The stain contains more oxygen, carbon and a significant amount of chlorine. Element map for iron (in blue) and oxygen (in red) (c) and element map for iron and chlorine (in yellow), of the same surface area (d). The area comprising chlorine closely matches the area with elevated oxygen levels.

band of grayish-brown staining was observed close to the strip edge. An EDS spectrum of a small oxide spot, observed under high magnification, reveals the presence of a high amount of oxygen and, due to the porous nature of the oxide, a high amount

of carbon (representing rolling oil remains). Closely associated with the corrosion spot is the presence of a relatively high amount of chlorine, which may have accelerated the corrosion process.

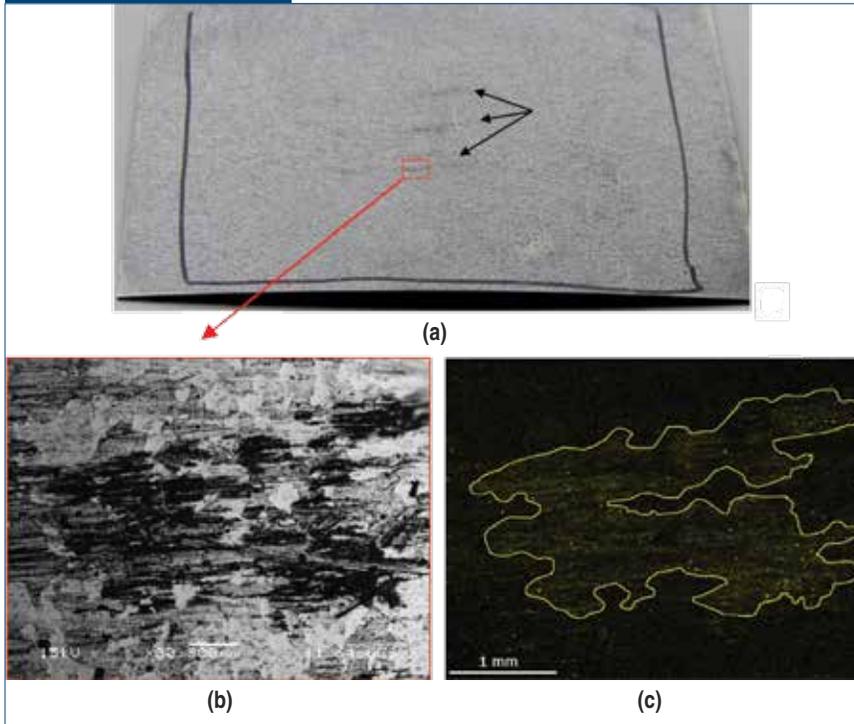
Figure 5

Cold Rolling — Rolled-In Calcium Soaps — Less frequent than corrosion defects, but not uncommon, are surface chemistry defects caused by rolled-in alien matter, such as iron soaps, calcium soaps or oily dirt comprising metal fines, oxide matter, or other contaminants (e.g., paint particles, filter material, sand, etc.). An example of a surface chemistry defect associated with calcium soaps is depicted in Fig. 5.

In this case, a Ca-containing bearing grease had contaminated the rolling emulsion, leading to the formation of small, sticky lumps of calcium soap. These were trapped in the roll bite, resulting in small, black, elongated spots on the full hard strip surface. By means of EDS element mapping, these kinds of defects can be easily identified. As shown in Fig. 5c, an element map clearly demonstrates that the alien matter comprises a significant amount of calcium. This could point to either calcium present in the water used to make up the rolling emulsion or to contamination of the rolling emulsion with a calcium-based grease. Analysis of the makeup water and of the bearing grease indicated that the bearing grease was the root cause of the defect.

Visual appearance of black stains caused by rolled-in calcium soap (black arrows) (a), backscatter image of one of the stains, revealing the lower density of the stain matter (in black) (b), EDS map for calcium (in yellow) of the same surface area (c). The outline of the area comprising calcium closely matches that of the stain.

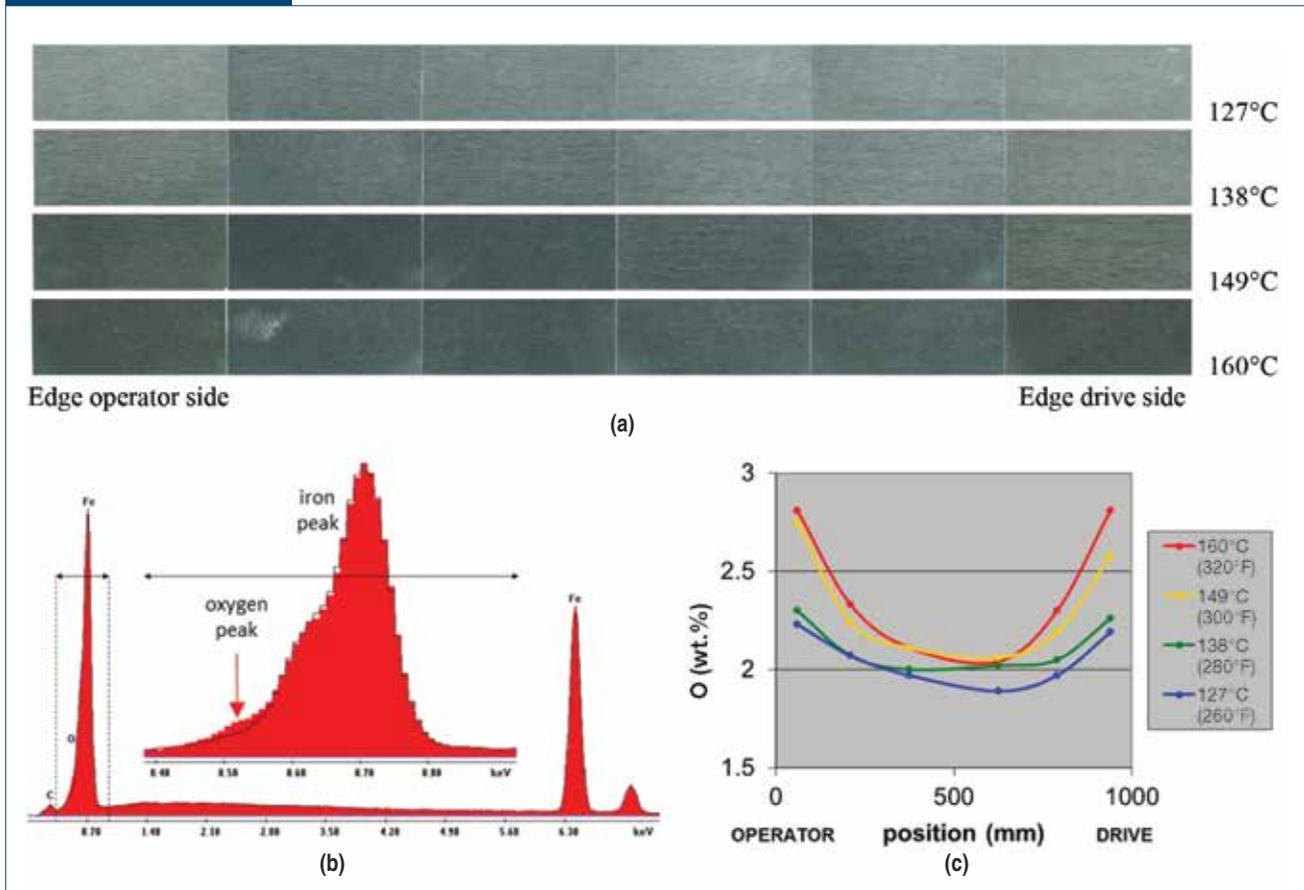
Figure 6

suspected to be the cause of coating defects (of galvanized steel, Galvalume[®], etc.). Surface oxidation may occur due to excessive exit strip temperatures after the cold rolling process. This has been studied systematically at a steel manufacturer by varying the strip exit temperature between 127°C and 160°C (260°F and 320°F). In Fig. 6a, it can be seen that the surface becomes darker/browner as the coiling temperatures increase. This effect is greatest at the strip edges, presumably due to the fact that these zones can be reached better by the atmospheric oxygen. Strip samples for every coiling temperature were obtained along the strip width and analyzed with EDS (at 15 keV). See Fig. 6b for a representative spectrum. The amount of surface oxygen was determined quantitatively and the result can be seen in Fig. 6c. It is confirmed that the oxygen levels (oxides) increase with coiling temperature and position closer to the edge. It also correlates with the surface discoloration. Please note that the oxygen levels should be interpreted in a qualitative sense only.

Surface appearance of 30 x 10 mm steel samples taken at various locations between operator and drive side and rolled at different temperatures (a), EDS spectra of surfaces with the lowest oxygen level (black outline) and the highest oxygen level (in red) (b) and plot of the amount of oxygen along the strip width, for the various coiling temperatures (c). Oxygen data refer to the uppermost ~1 μm surface layer.

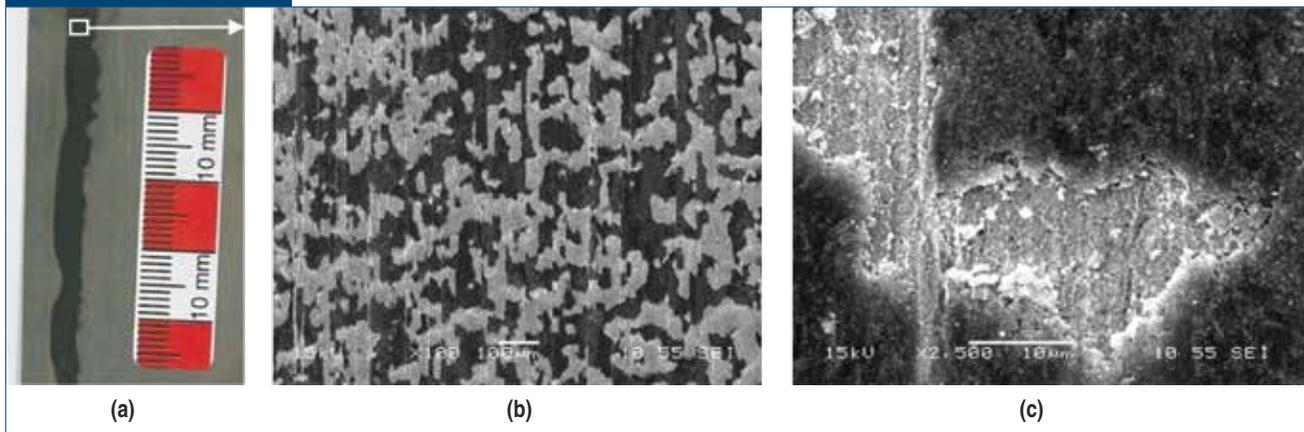
Figure 7

Annealing — Carbon Edge — After the annealing process, a carbon edge is sometimes found at the edge of the strip, also called snaky edge. This defect is the result of the deposition of carbon. At the high temperatures occurring during annealing,

the organic components in the remaining rolling oil decompose into short-length alkanes, mainly methane. Under some conditions, and catalyzed by iron, the methane decomposes into carbon, which settles on the surface, and hydrogen gas. In case of high hydrogen levels in the annealing gas, this reaction is slowed down, which explains the usual preference for pure H₂ gas in annealing rather than HNX. The aforementioned catalytic action of iron is “poisoned” by the presence of sulfur, which is why sulfur compounds are usually included in the rolling oil. This defect can also be counteracted by introducing a constant temperature step in the annealing cycle (at lower than the maximal annealing temperature), which gives the organic molecules time to escape the coil without depositing as carbon.

In Fig. 7a, a typical example of a carbon edge can be seen (the edge of the strip is visible on the left). With the SEM, it can be seen that the carbon (i.e., the dark patches) is deposited irregularly on the surface (Fig. 7b). Figs. 7b and 7c show the flaky nature of the carbon, which may be due to a rupture process during opening of the coil.

Example of a carbon edge (a), secondary electron images at 100x (b) and 2,500x magnification (c).

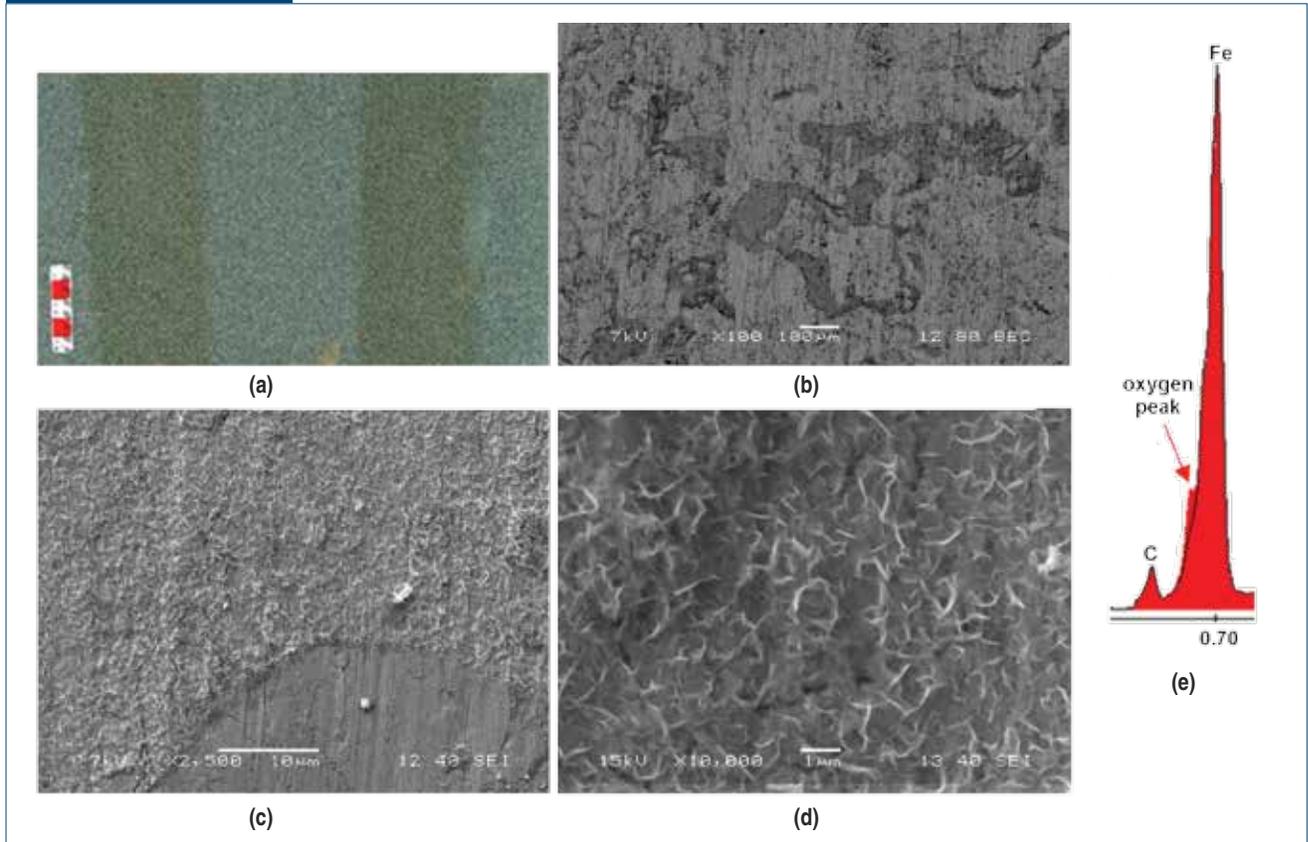
Figure 8

Wet Temper Rolling — Staining — After the wet temper process, a particular type of staining sometimes develops, frequently called “brown staining.” This staining occurs as long, straight, or slightly meandering bands of brown or yellowish discoloration, 10–30 cm wide, at the center of the strip. Sometimes a lighter band is found at the center of the staining. A typical example can be seen in Fig. 8a. The shape of the band is usually mirrored on the surface of the adjacent lap. The discolored areas are generally distinguished from the reference surface by a small but clearly increased oxygen peak in the EDS spectrum (Fig. 8e). On the microscopic scale, sponge-like structures can often be found, which are also mirrored on the surface of the adjacent lap. This corroborates the scenario discussed earlier in this paper (“Chemistry and Morphology”): the oxides form locally and fill the space between touching asperities, and are ruptured upon opening the coil.

The staining is the result of a mild corrosion process occurring in the coil, where it develops mainly in

Typical example of wet temper staining (a) and its features discussed in the text. In (e), the EDS spectra of staining (red) and reference (black outline) are shown.

moist areas. Moist areas can be created by the migration of temper fluid to the narrowest spaces between the windings under the influence of capillary forces. The staining pattern, therefore, can be influenced by strip shape (crown). Moist areas may also be created by locally high fluid film thickness during the temper rolling process, for instance in the middle of the strip. This could be due to strip shape and work roll crown, which could, in turn, be affected by roll force.

One contributing factor that can be hypothesized for this defect is the state of the surface as it is presented to the wet temper mill. If the storage time

between annealing and wet tempering was too short, the passivation (reoxidation) of the annealed steel surface would have progressed insufficiently, and the surface would be very sensitive to oxidation/mild corrosion. The center of the strip is hardest to reach for reoxidation, which may contribute to the apparent higher sensitivity there. This also explains the higher sensitivity for staining when the coil is wound very tightly, i.e., with high coiling tensions. The passivation process may also depend on the humidity (fluctuations) in the atmosphere, which could explain the strong influence of certain climatic conditions on this defect.
